STS-1 Orbiter Final Mission Report

August 1981

National Aeronautics and
Space Administration

Lyndon B. Johnson Space Center
Houston, Texas

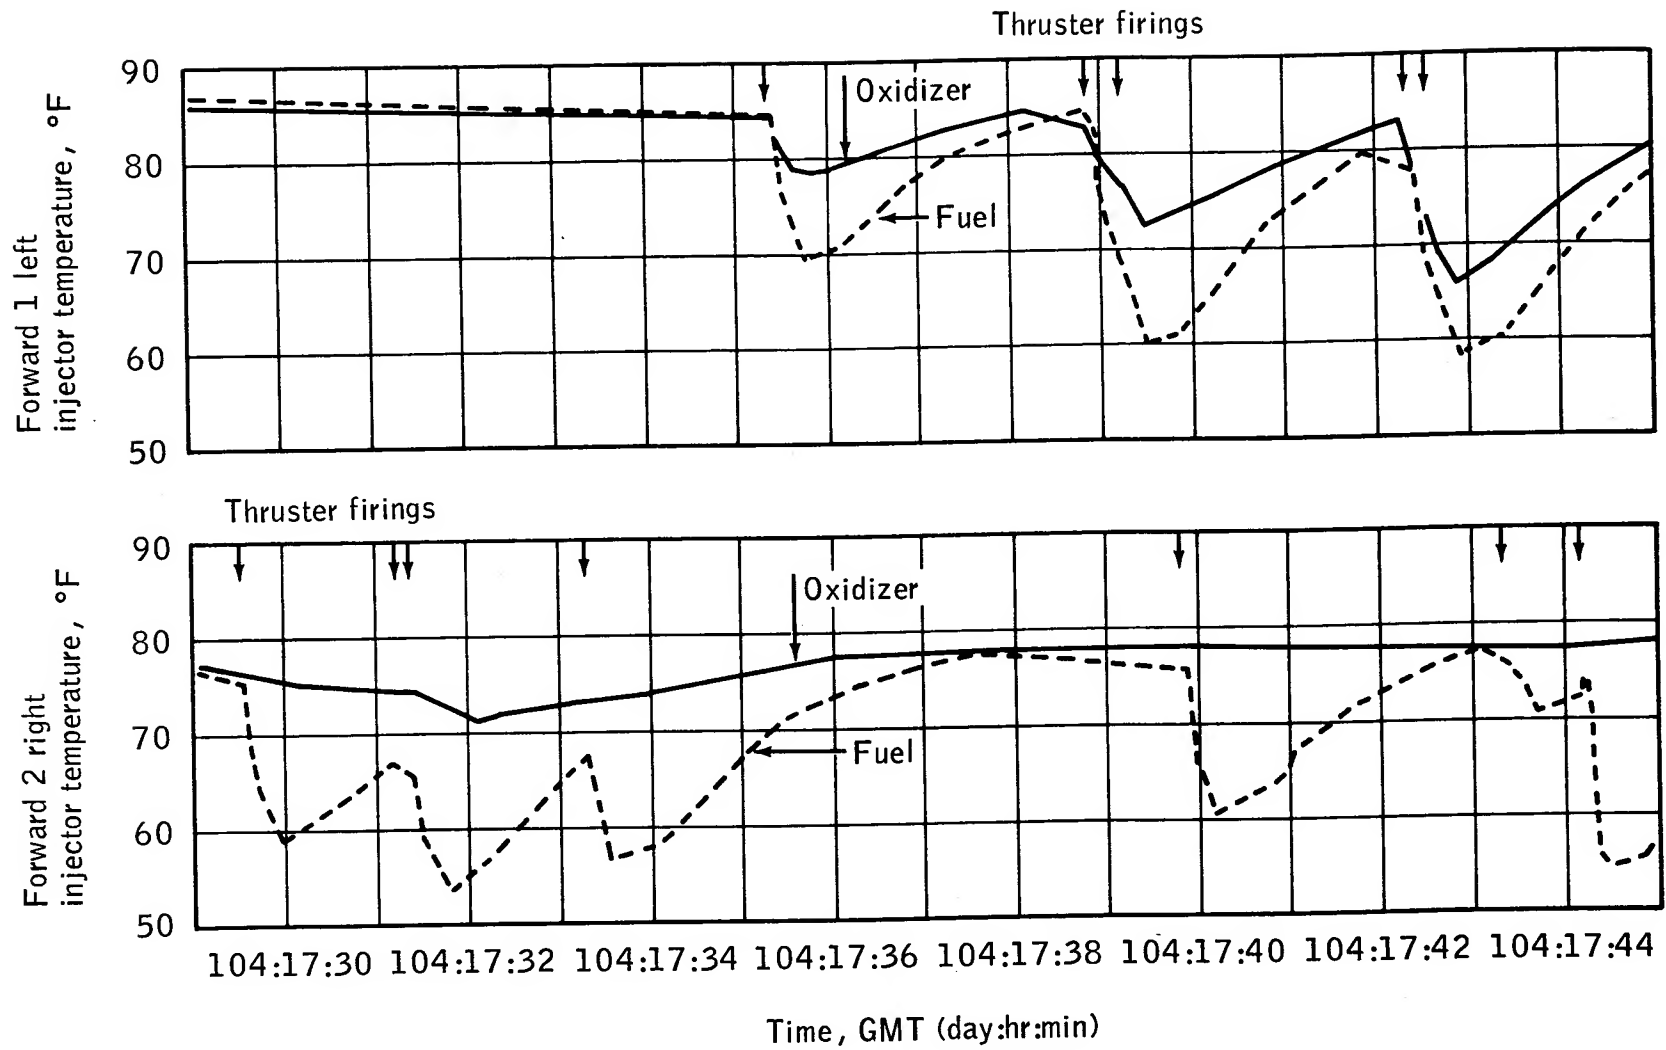
The oxidizer leak detector on thruster forward 2 right (F2R) did not track the transient evaporation cooldown that occurred on the fuel leak detector. An apparent thermal open exists between the oxidizer leak detector and the injector tube, and, therefore, a large thermal lag exists between the tube temperature and what the leak detector senses (fig. 2-4). See section 8.0, flight test problem report 50, for a discussion of this anomaly.

Figure 2-4.- Oxidizer leak detector - injector tube thermal log data.

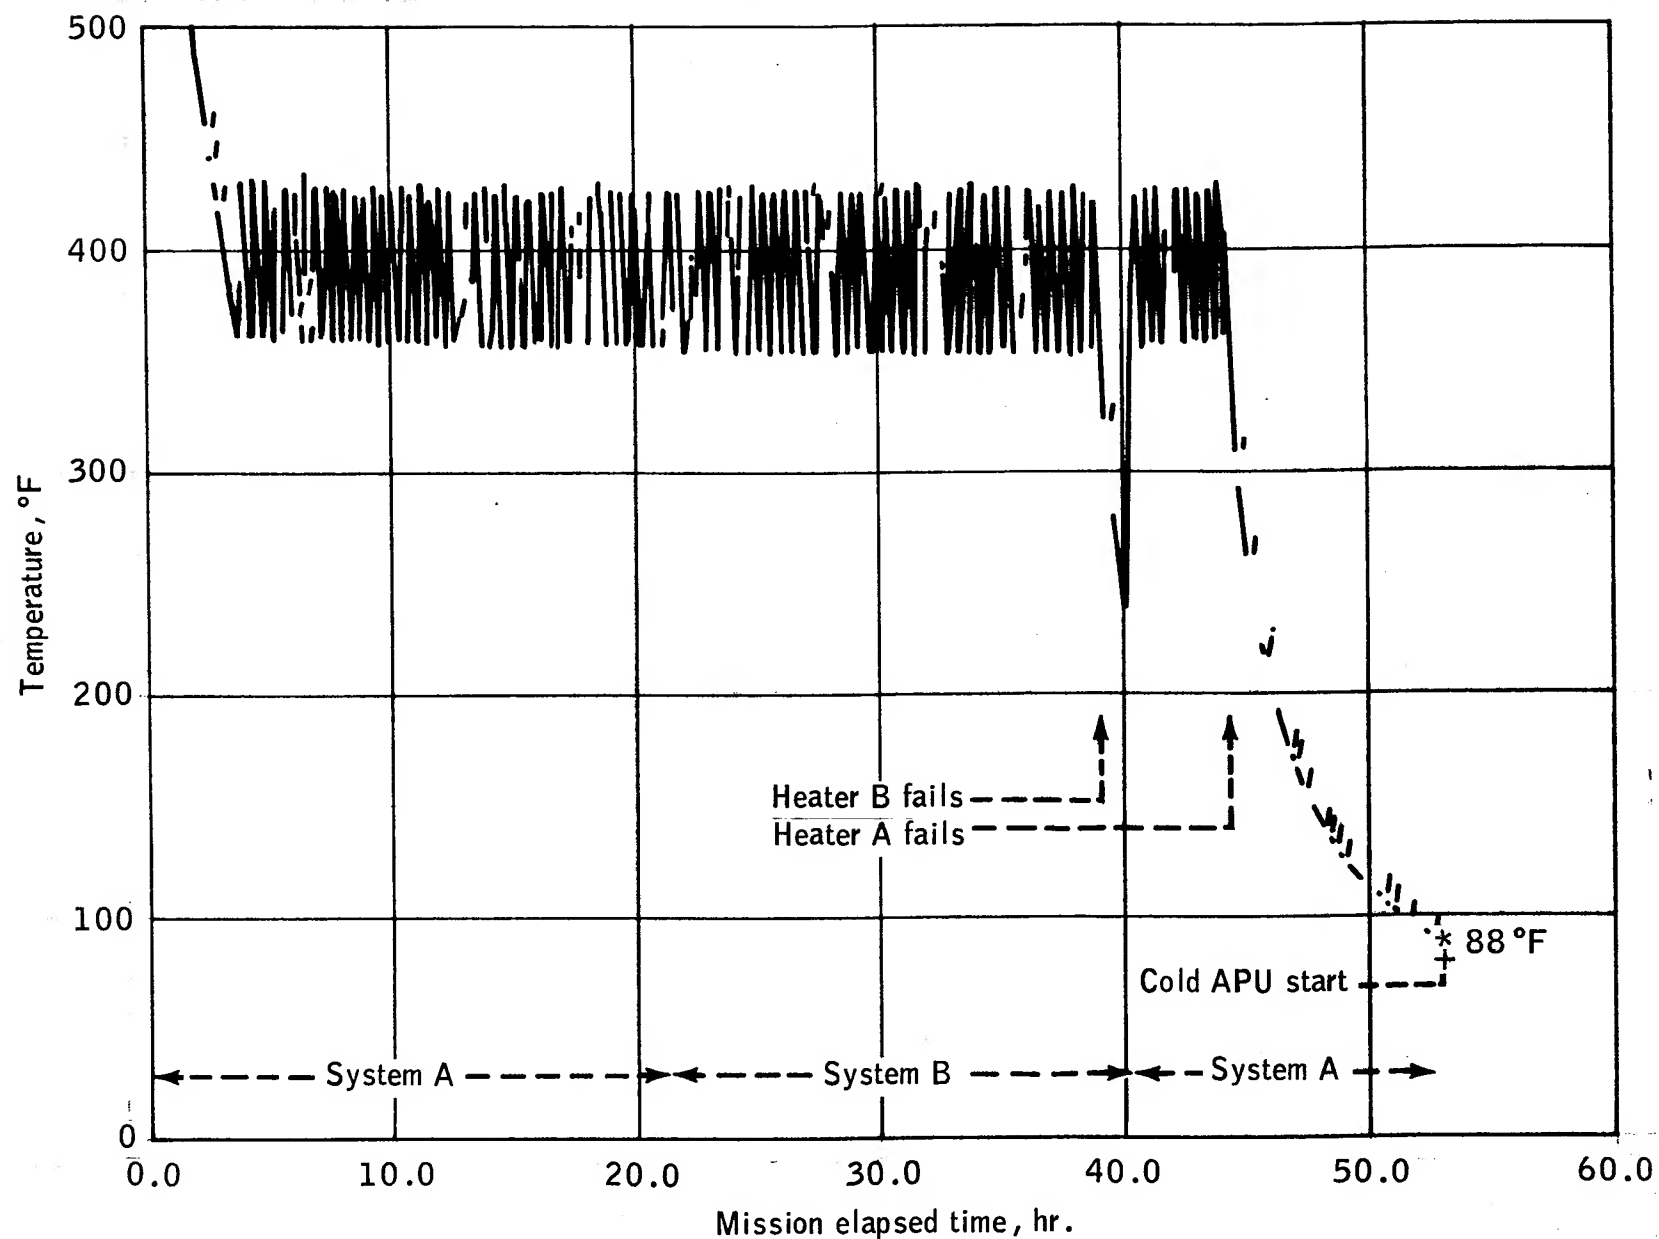
Failures occurred in both of the APU 2 gas generator heaters. Both failures occurred late in the mission, as shown in figure 2-5 (see section 8.0, flight test problem report 19). The fuel pump and valve temperatures were 75° to 80° F, and the gas generator temperature was 88° F at APU start. The cool gas generator temperature necessitated a "start override" start of APU 2, and this initiated 209 sec of injector cooling before starting. APU 2 started within 4 sec after the cooling cycle was completed.

Figure 2-5.- APU gas generator heater failures

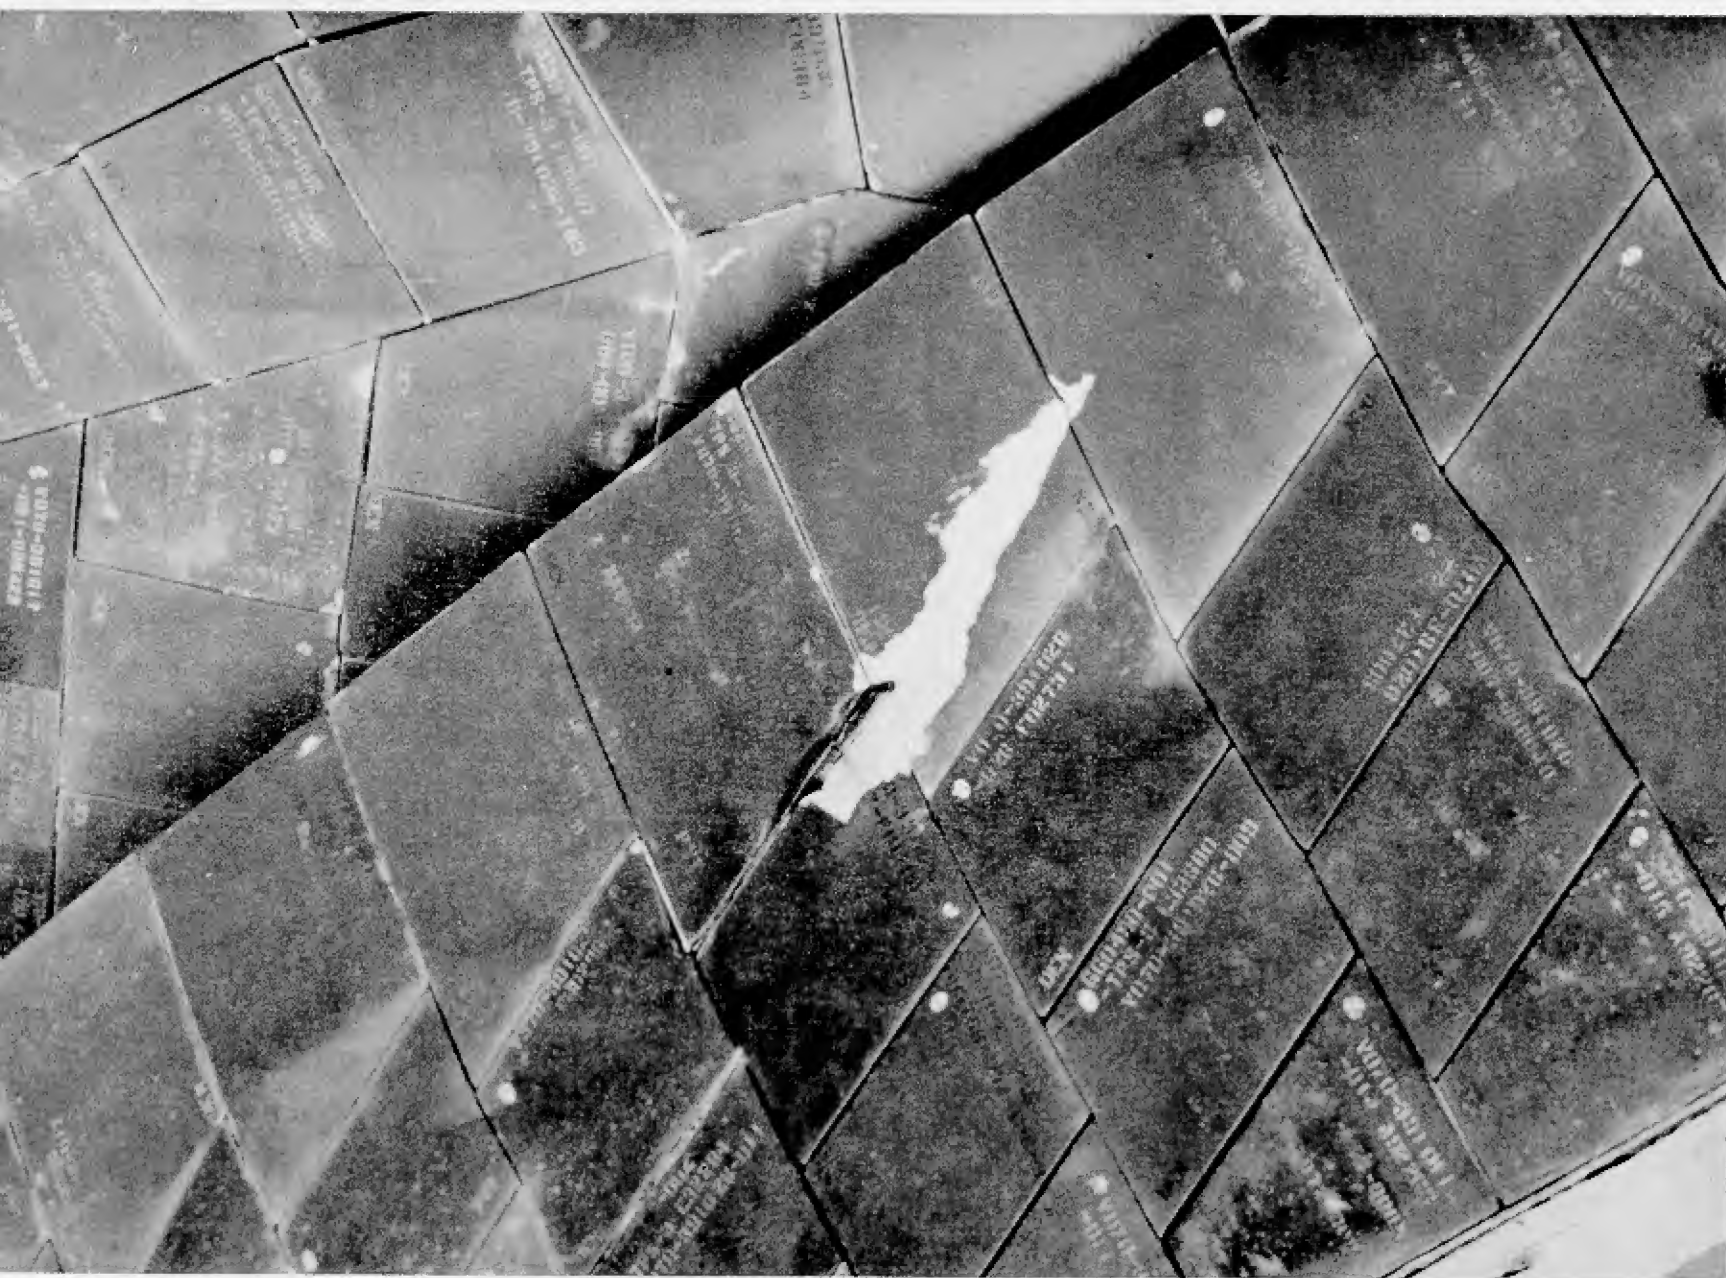
Figure 2-21.- Thermal damage to right nose landing gear door.

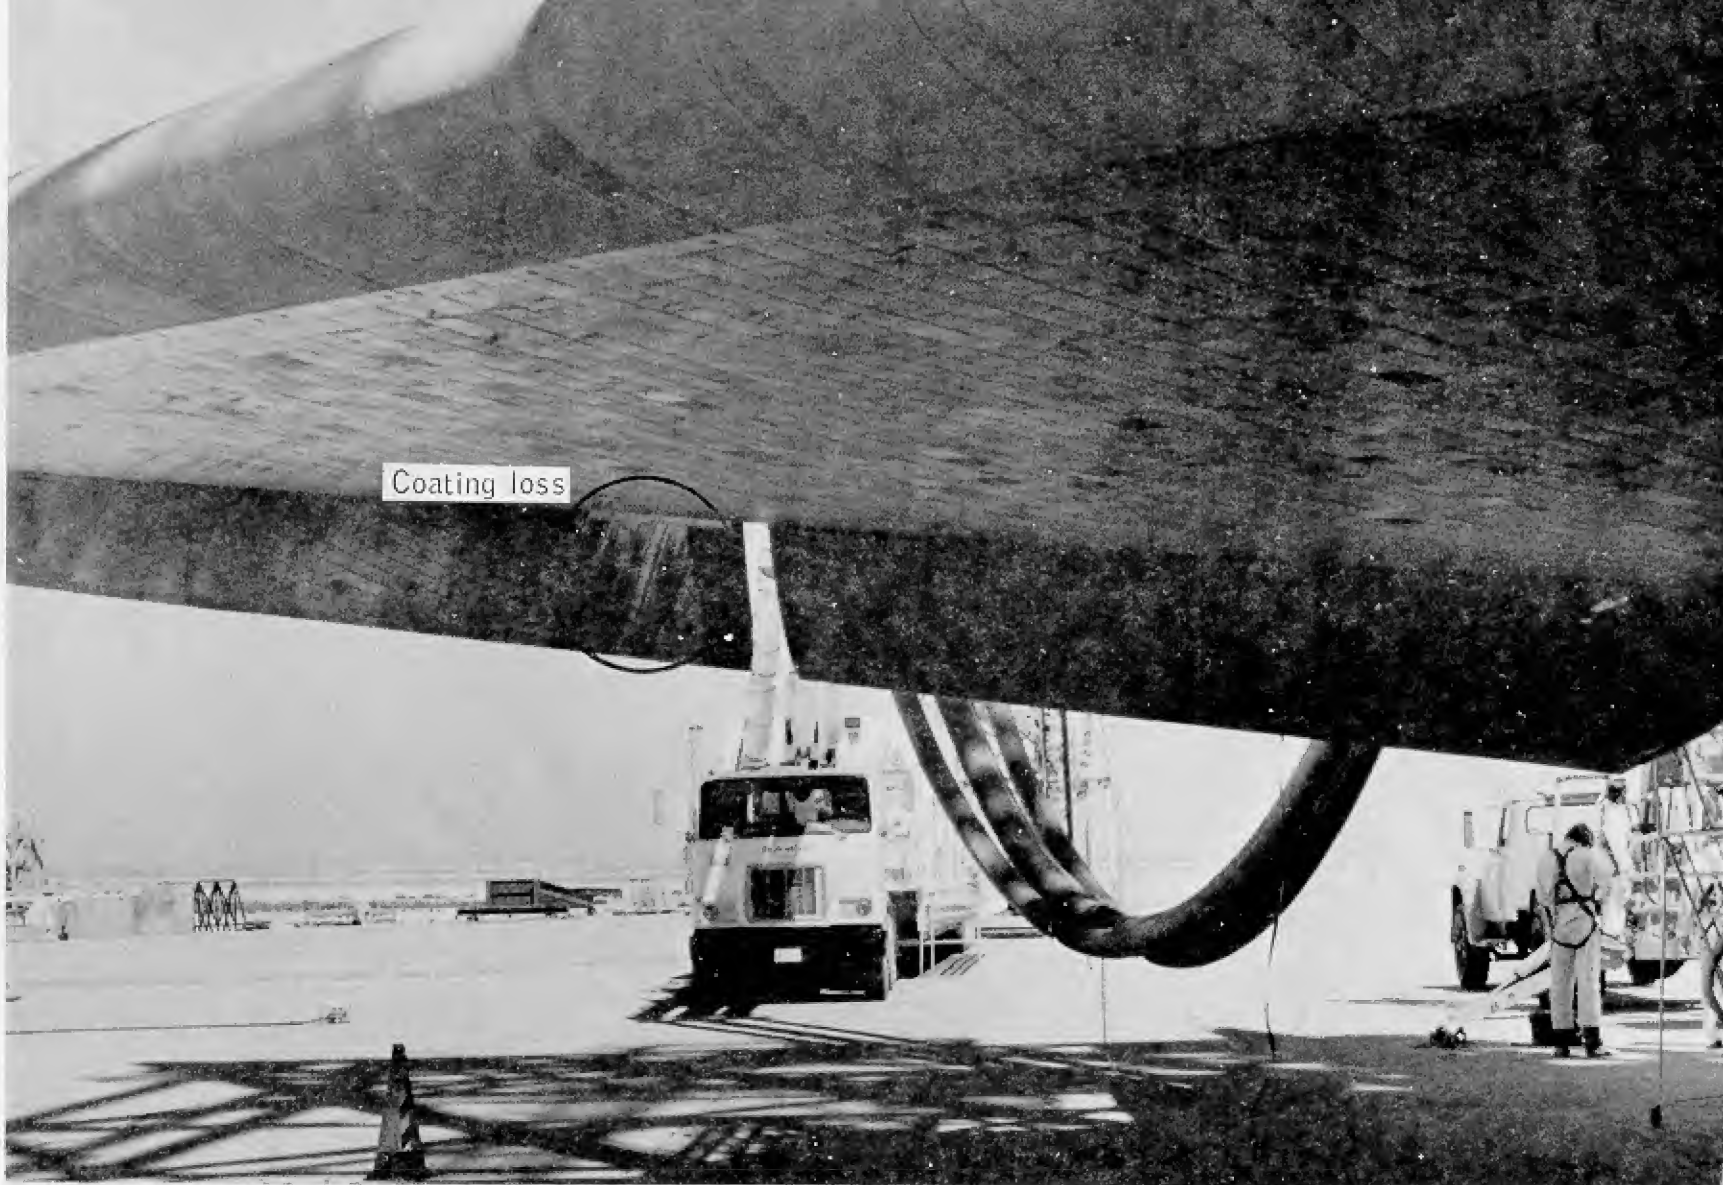
Figure 2-22.- Coating loss on lower surface of right inboard elevon.

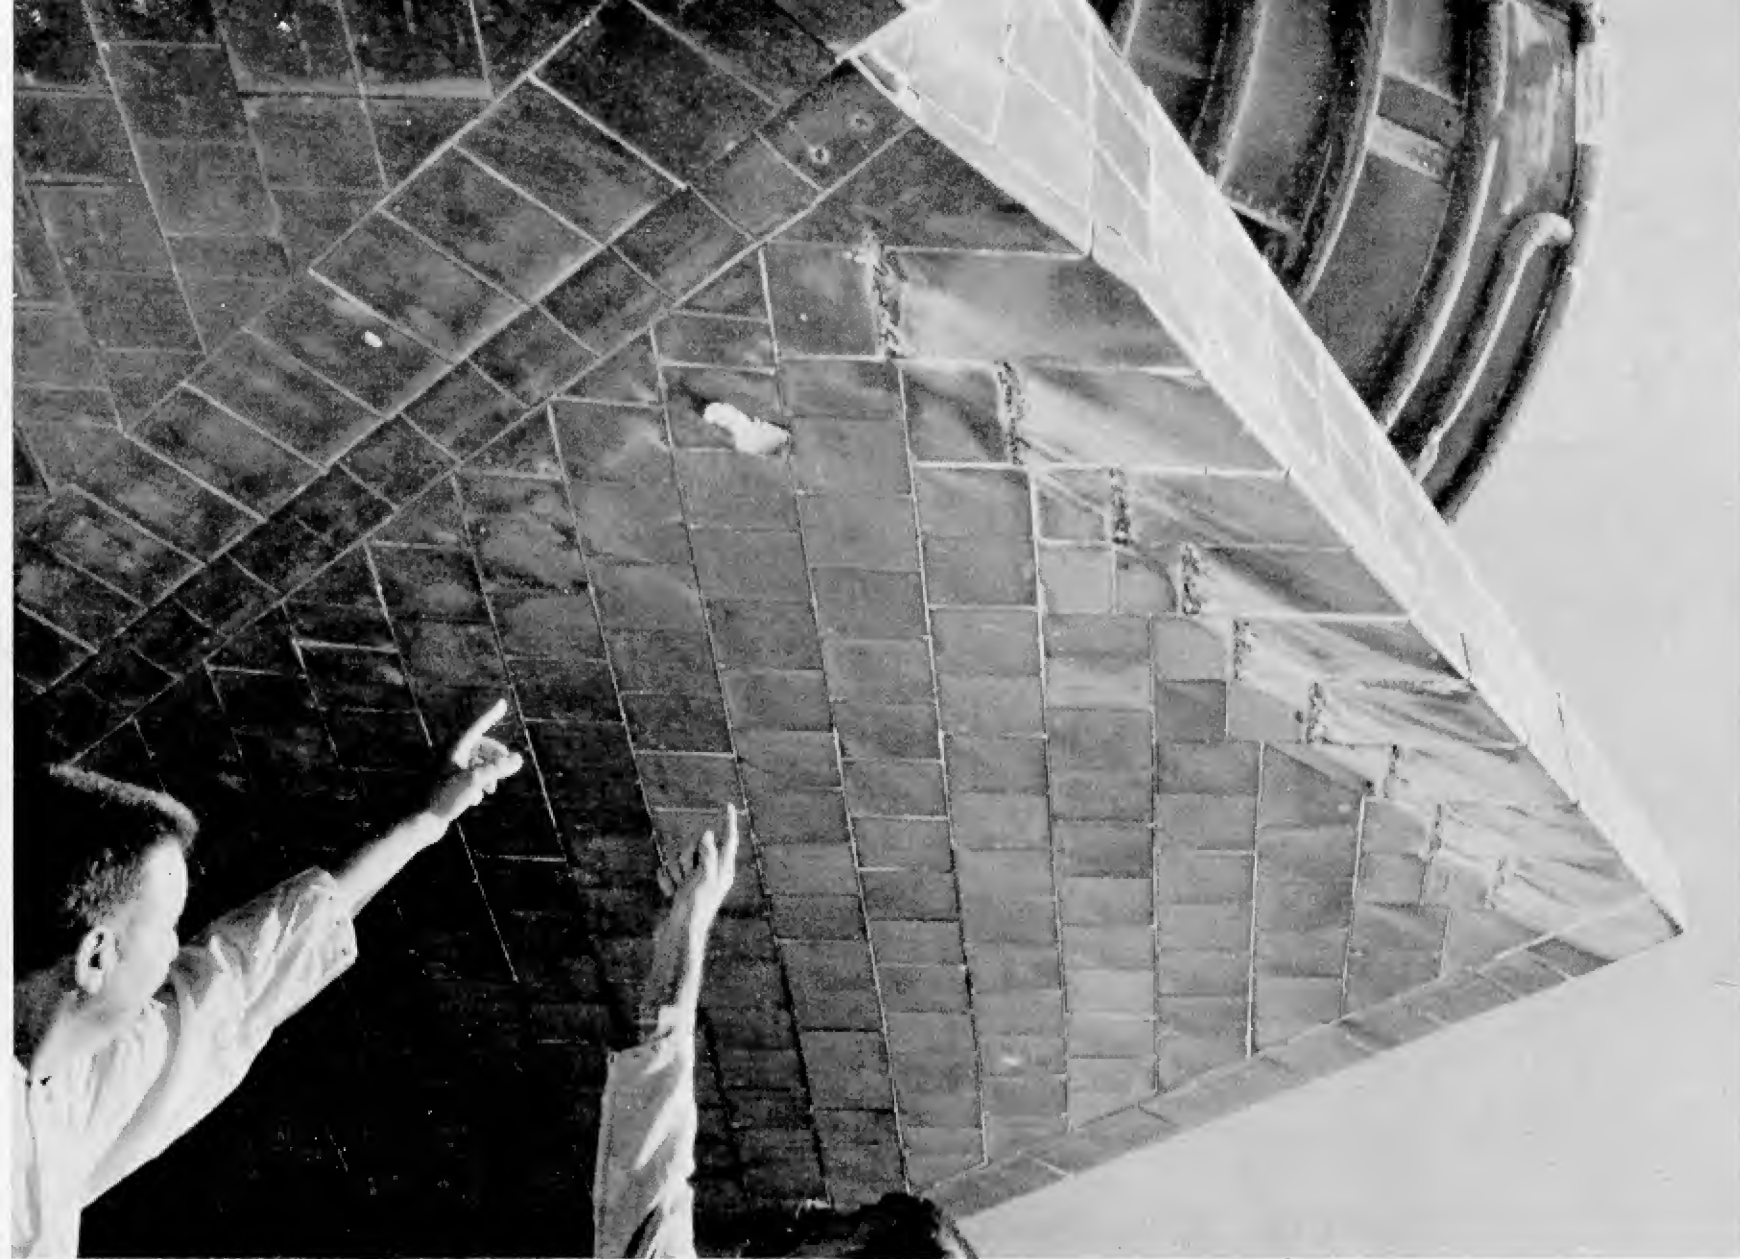
Figure 2-23.- Impact damage to left lower forward region of body flap.

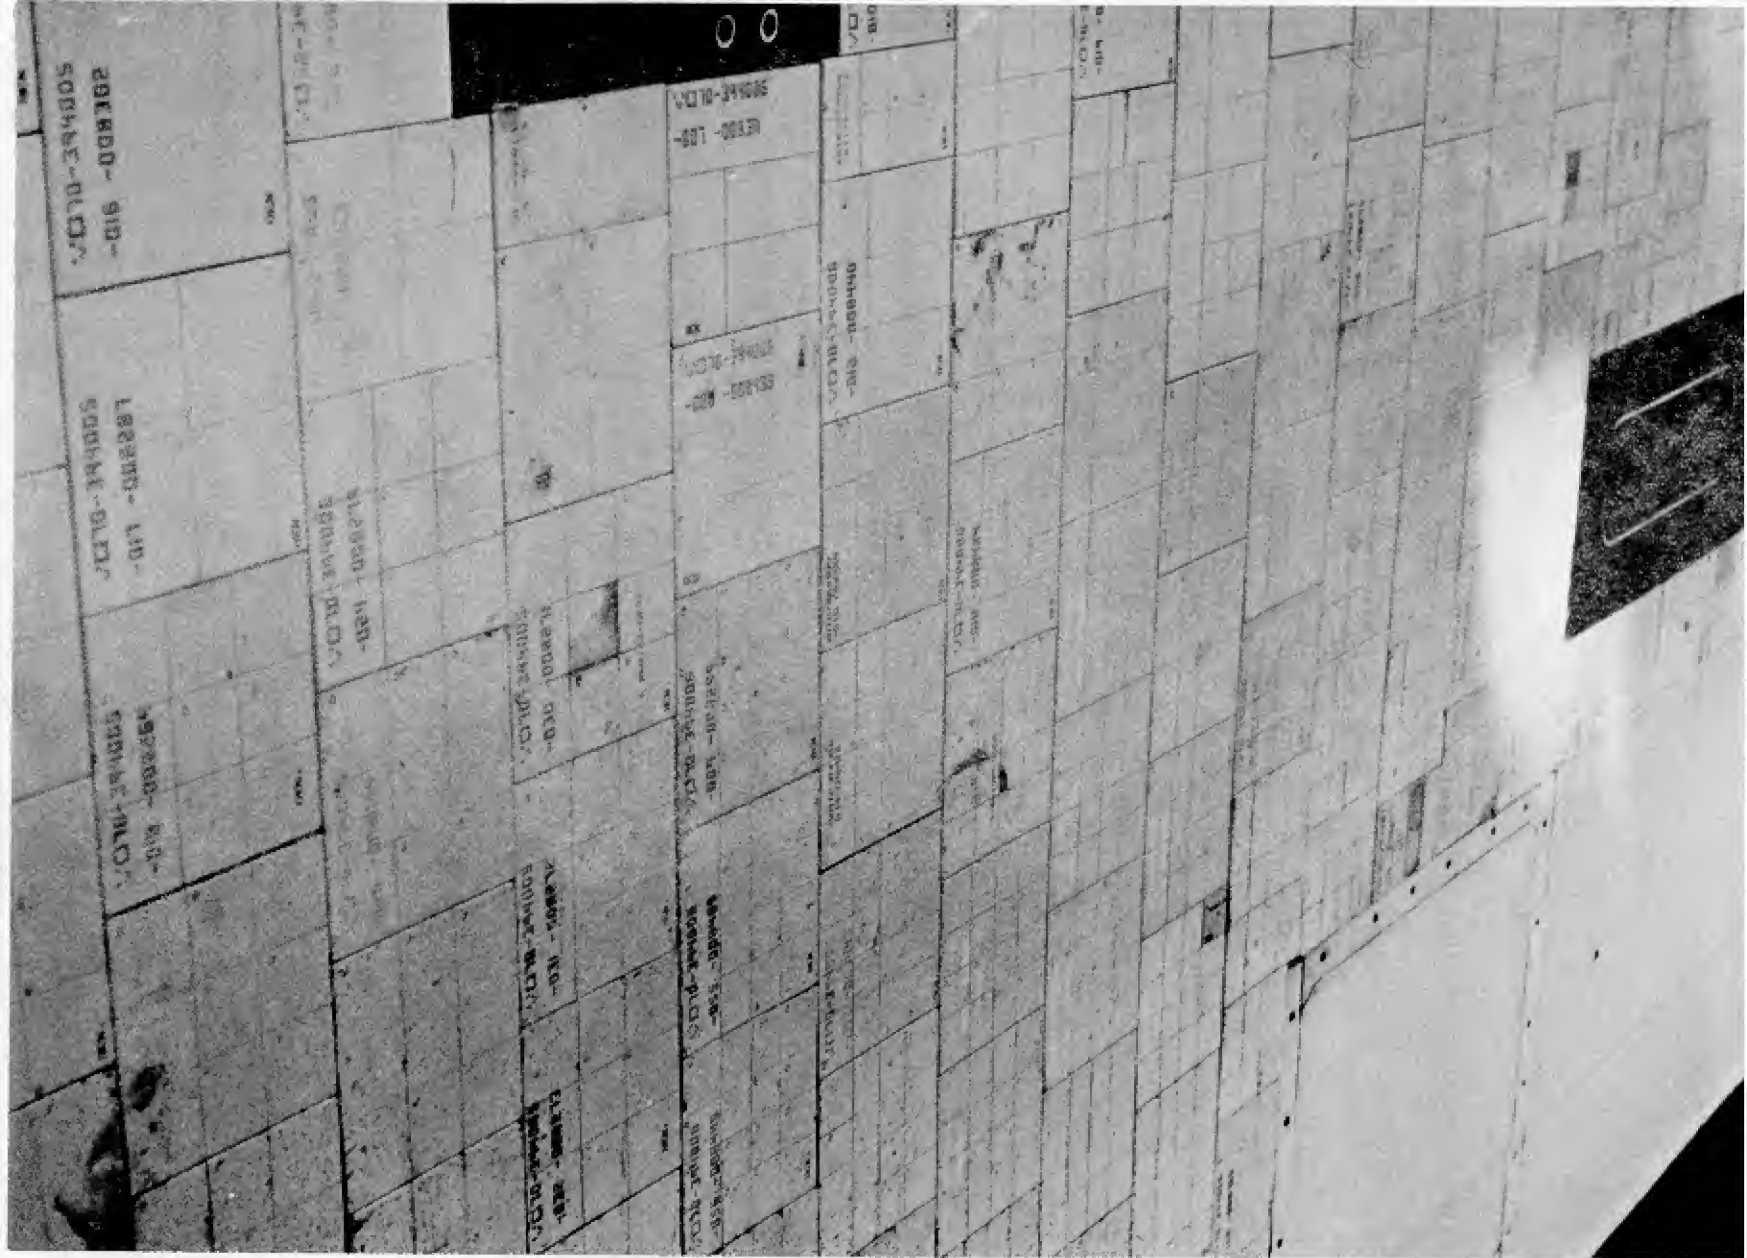
Figure 2-24.- Coating loss caused by unknown contaminant.

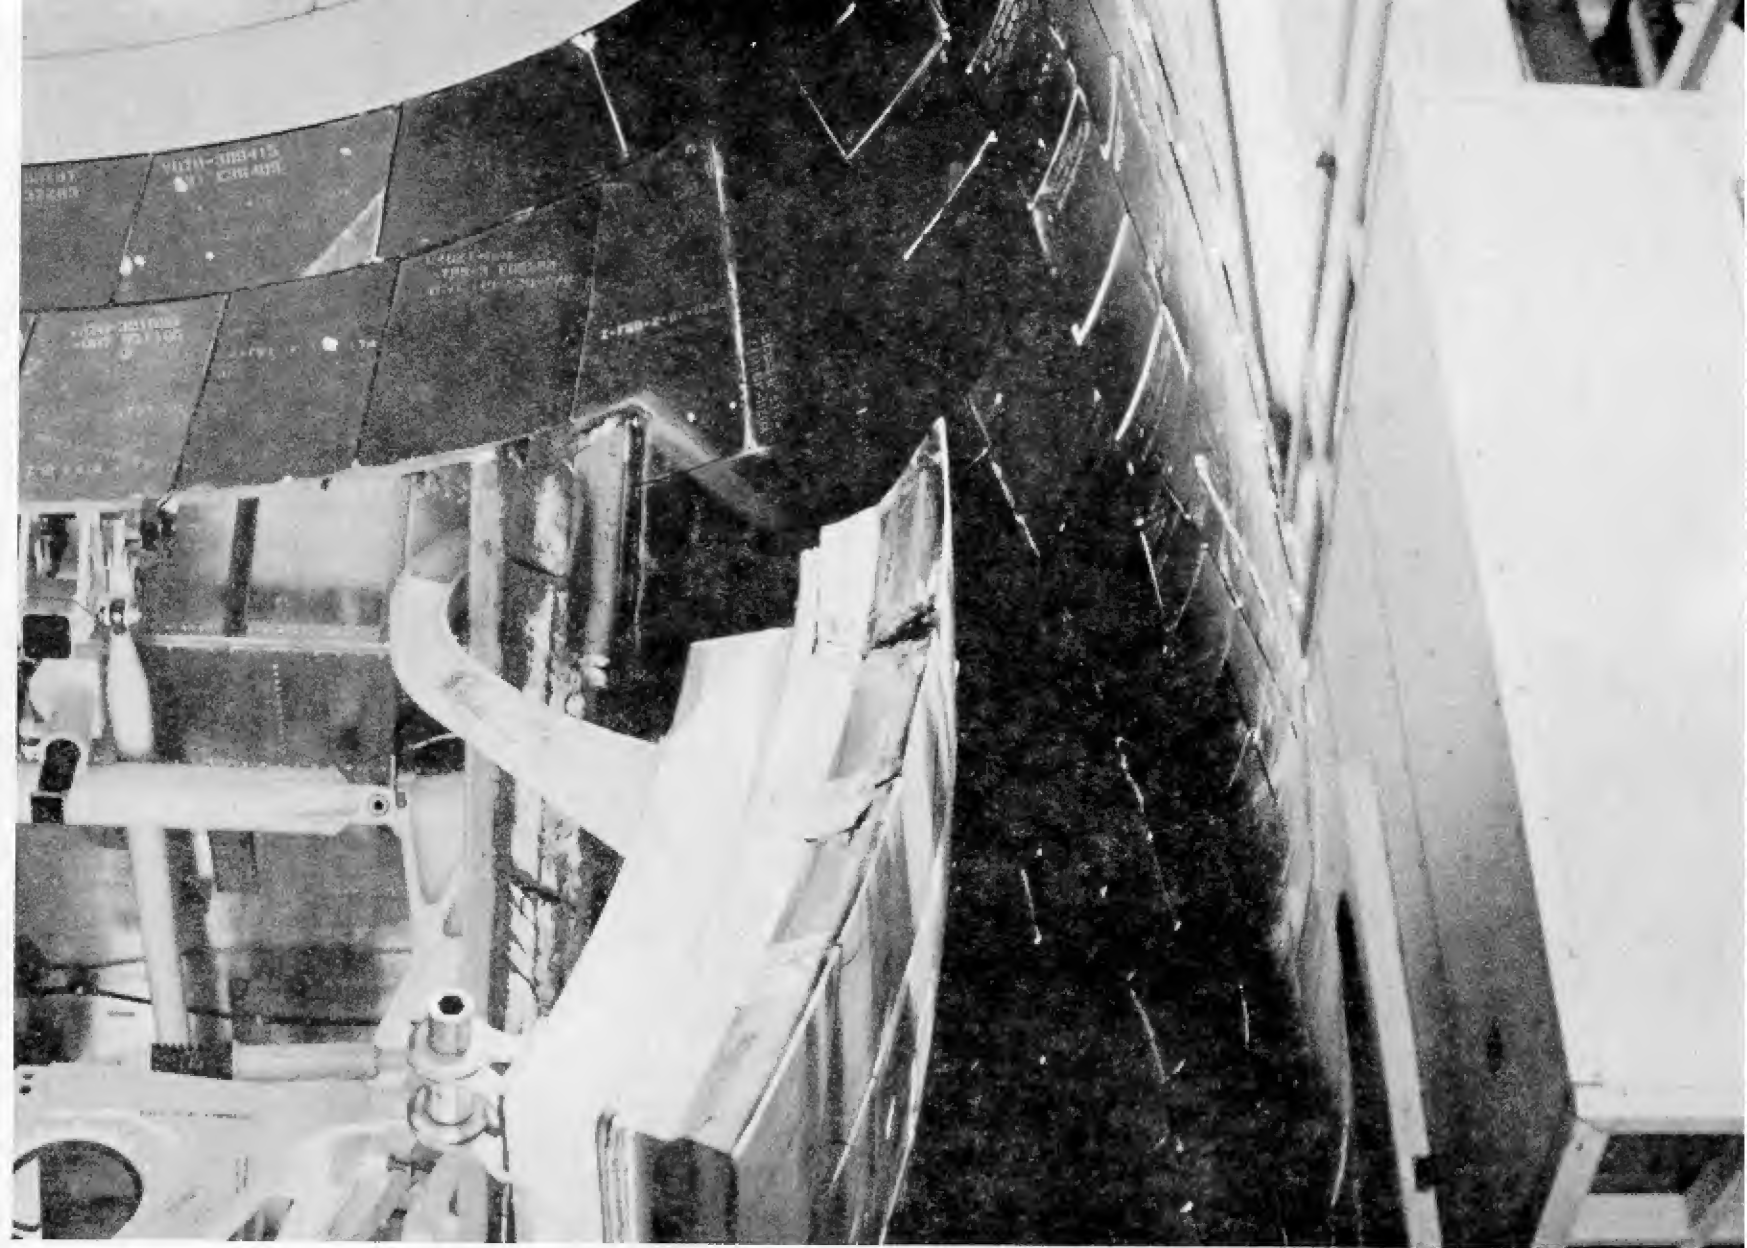
Figure 2-25.- Breaching of thermal barrier on leading edge of left nose gear door.

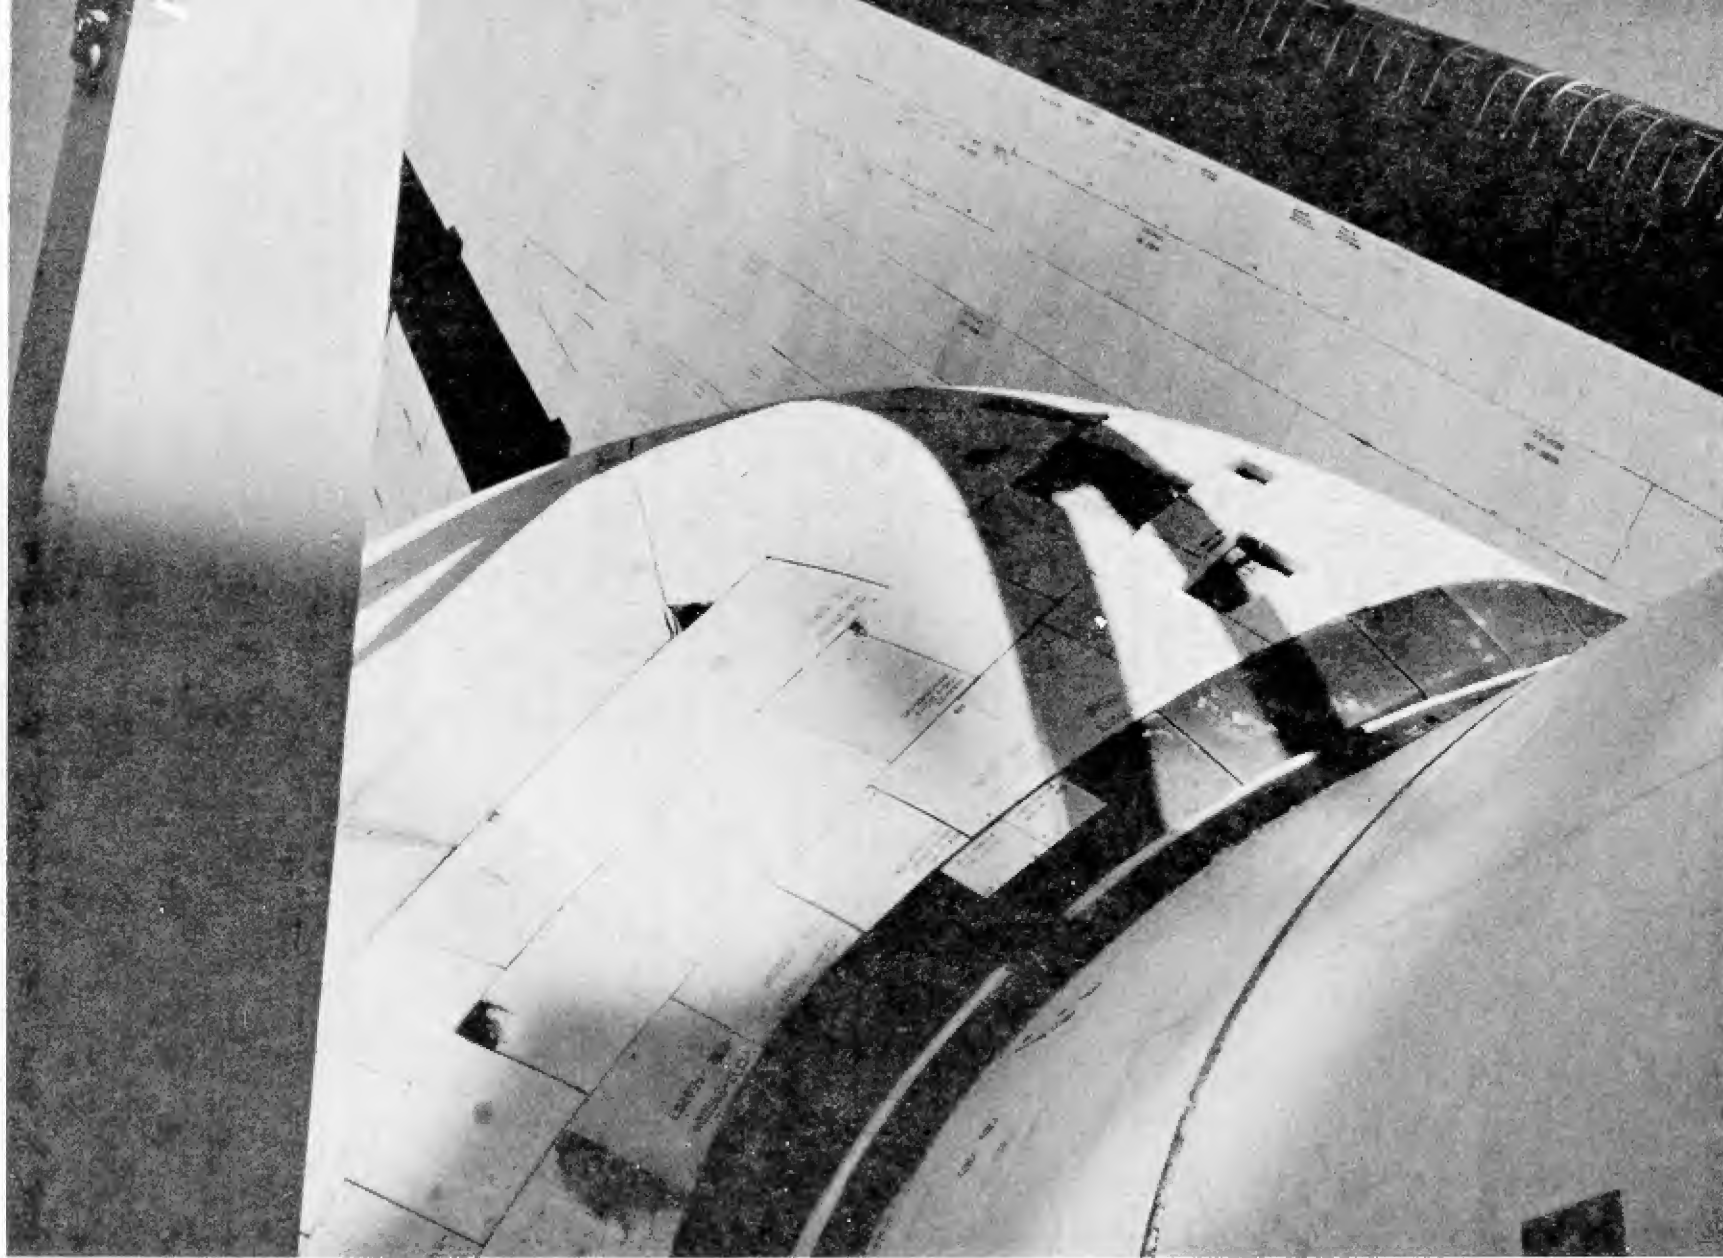
Figure 2-26.- Areas of lost tile on right OMS pod.

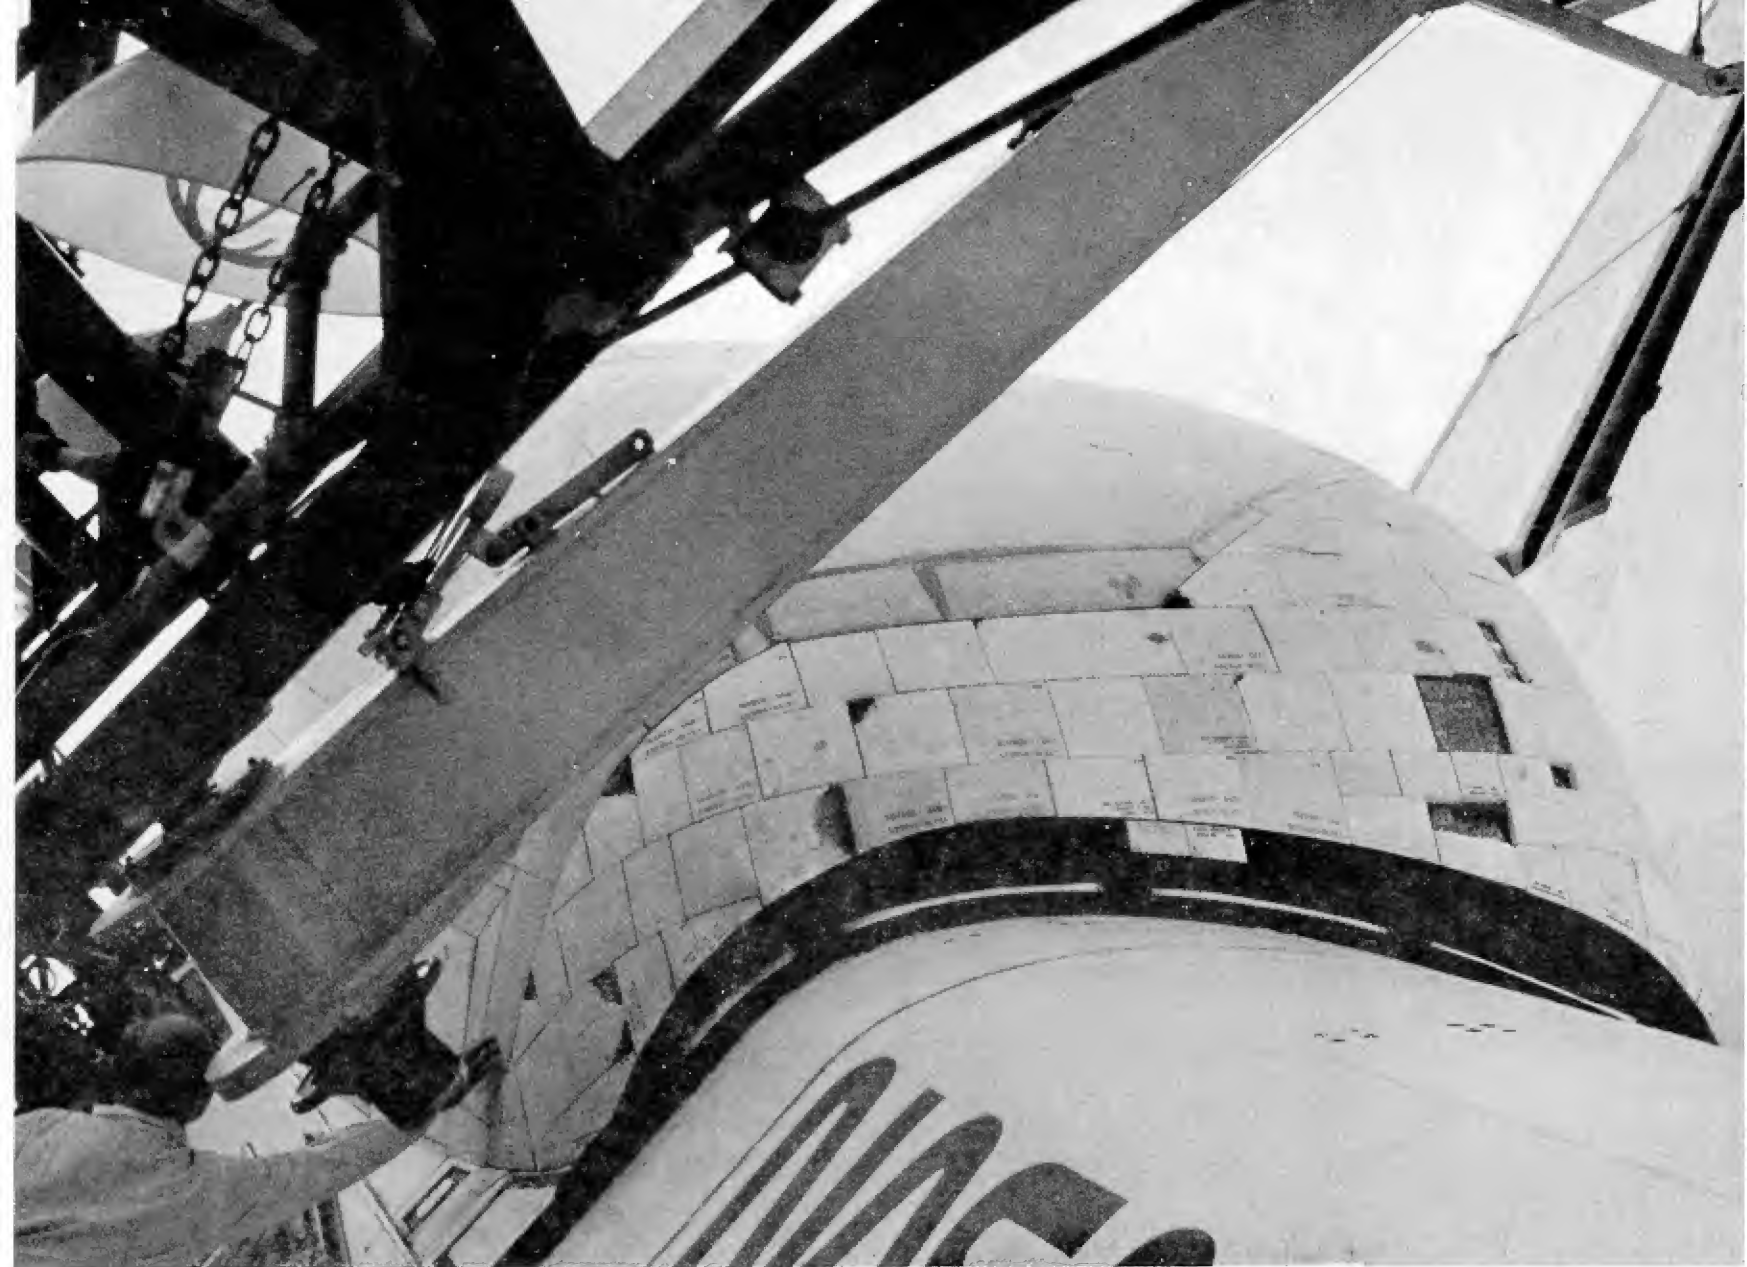
Figure 2-27.- Scorching of tile on forward edge of OMS pod.

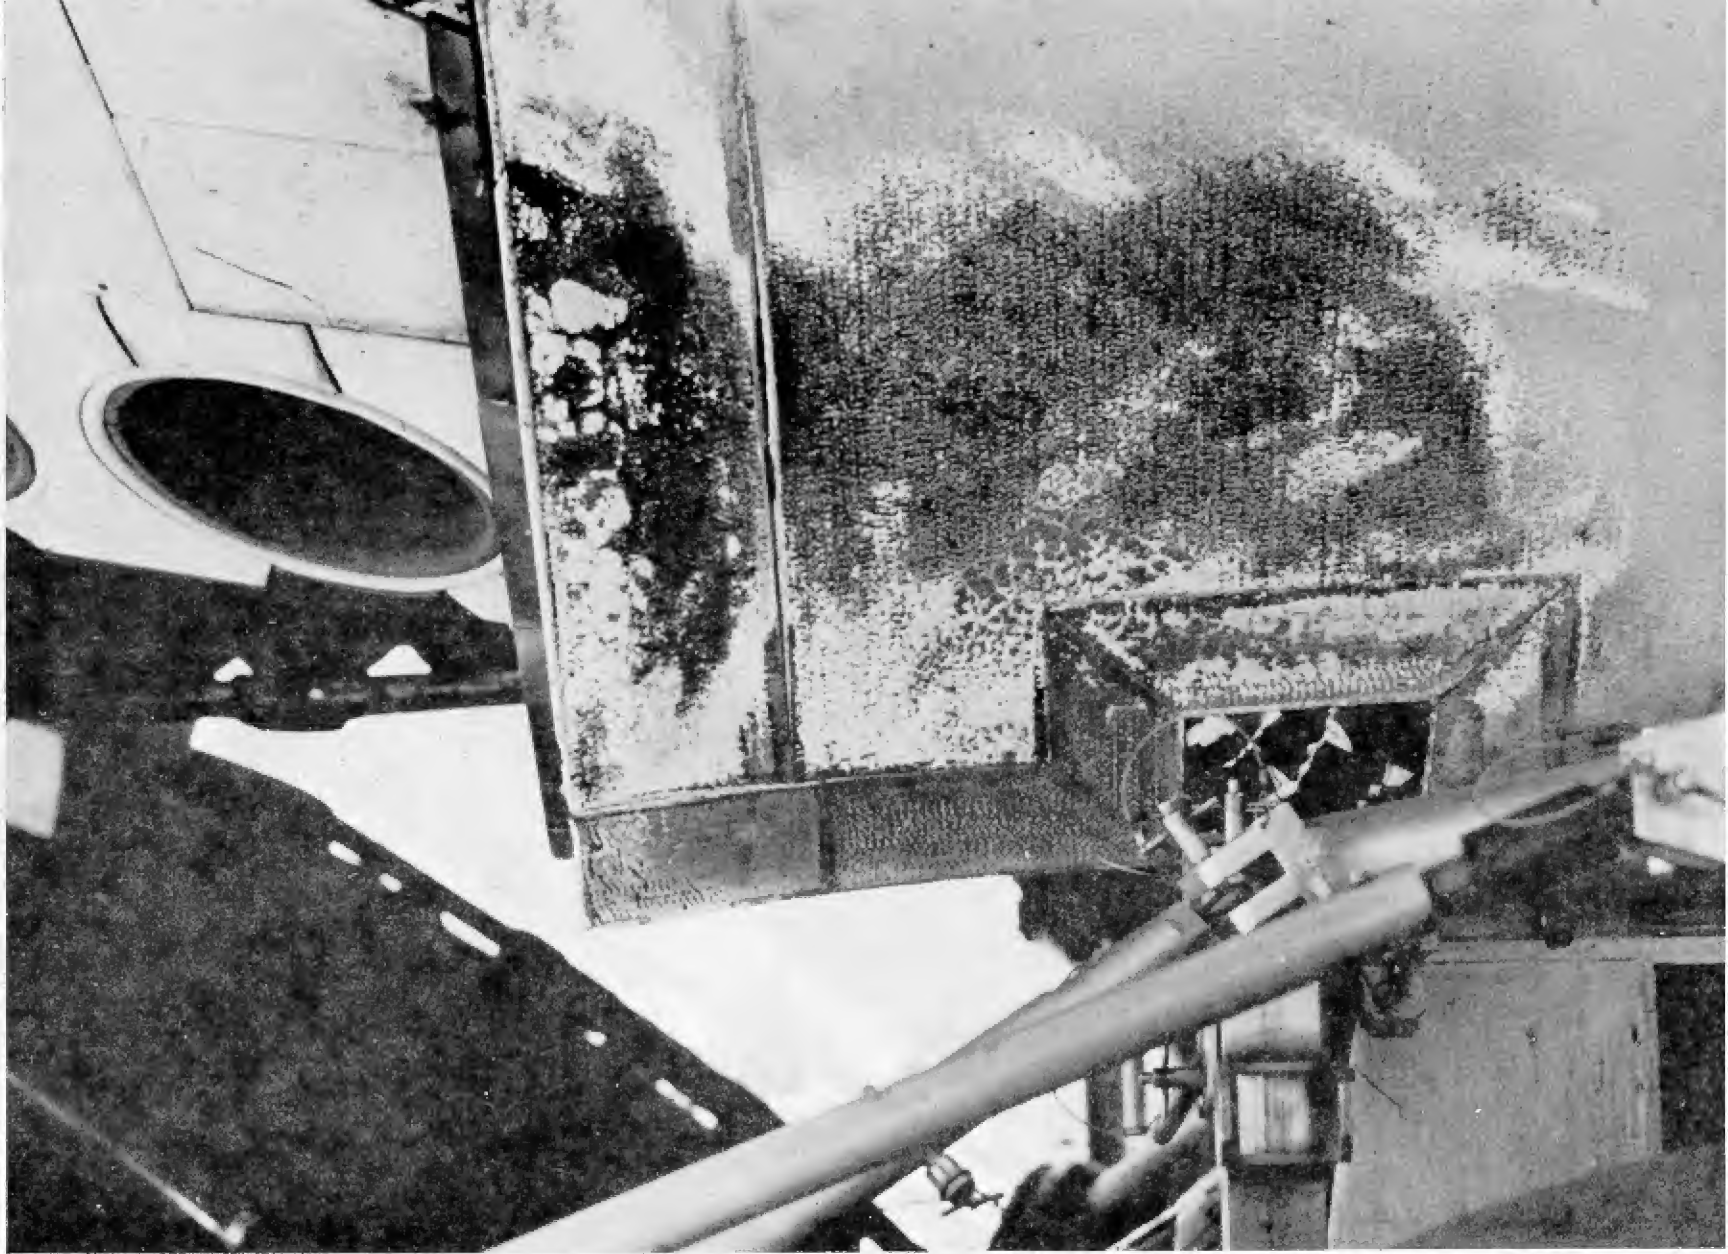
Figure 2-28.- Delamination of OMS pod structure.
